Shipping Insurance Claim Details

Item damaged by UPS, in transit from Los Angeles USA, to Sydney Australia. Shipito parcel: KA. UPS tracking: 1Z8R764F6702911770 Received at Botany Depot, Sydney on Tuesday morning 20201006.

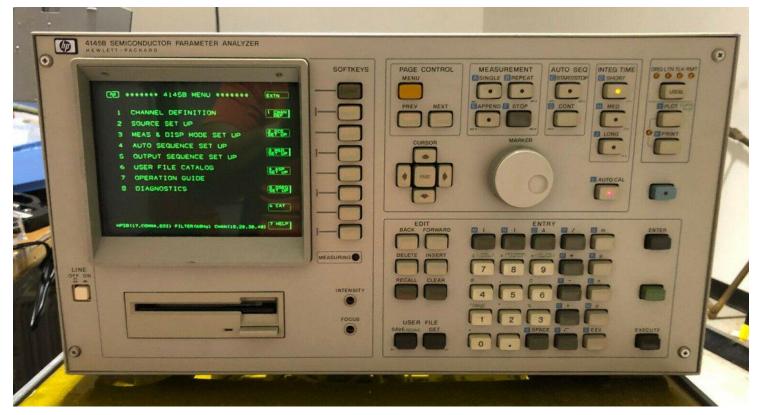
Ebay seller's pic that best shows the front panel. Note all 4 corners in perfect condition.

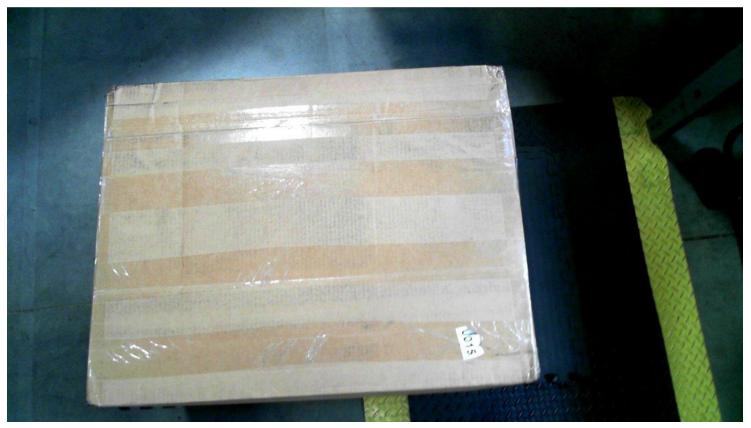
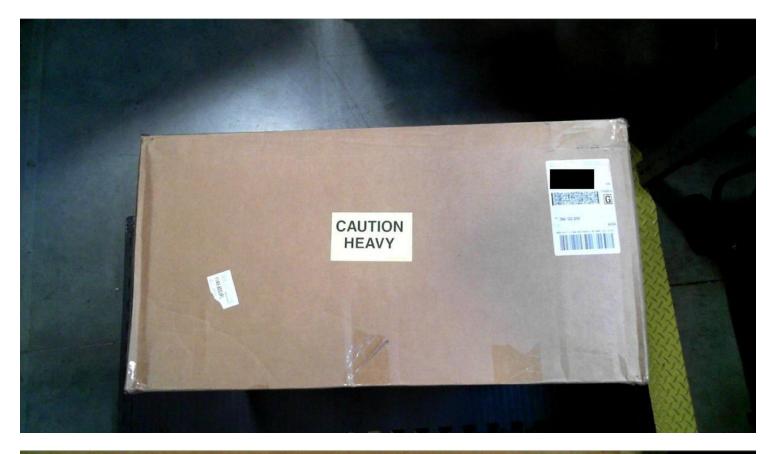
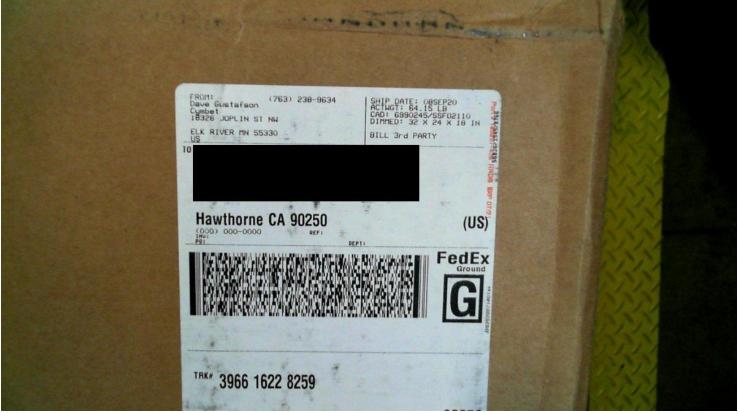
This is the first set, 17th September:

Note that the box is still in pretty good condition after US domestic shipping.

Even though the seller hadn't bothered to add any 'Fragile' stickers. US domestic shipping by FedEx.

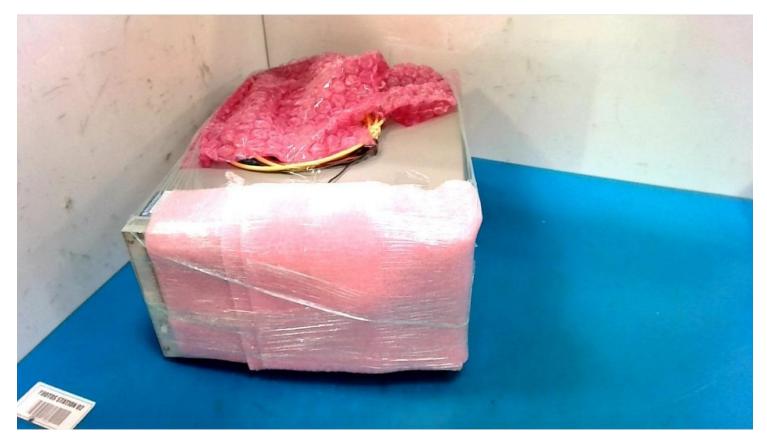
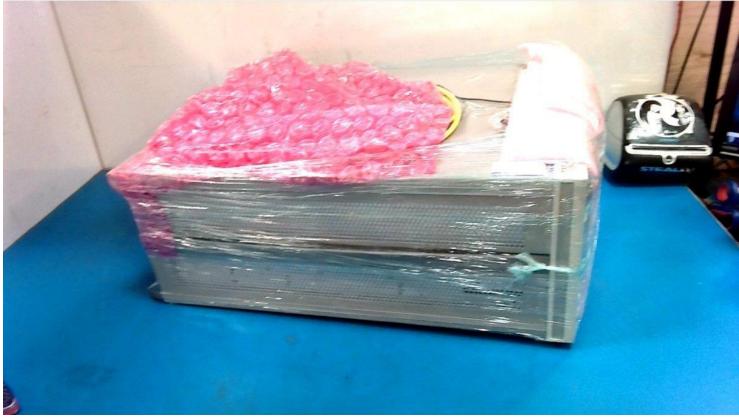
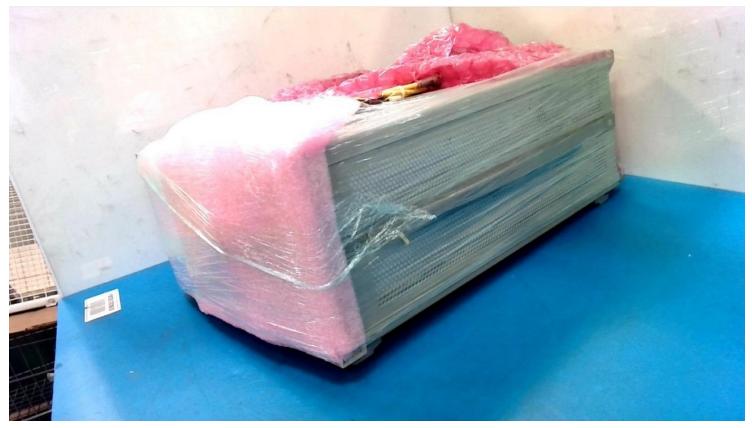
The next three photos were Shipito's initial 'unpacked photos.' In these you can't actually see the front and rear faces of the instrument; the areas most delicate and prone to damage. Which is why I had to ask Shipito to do it again, propperly.

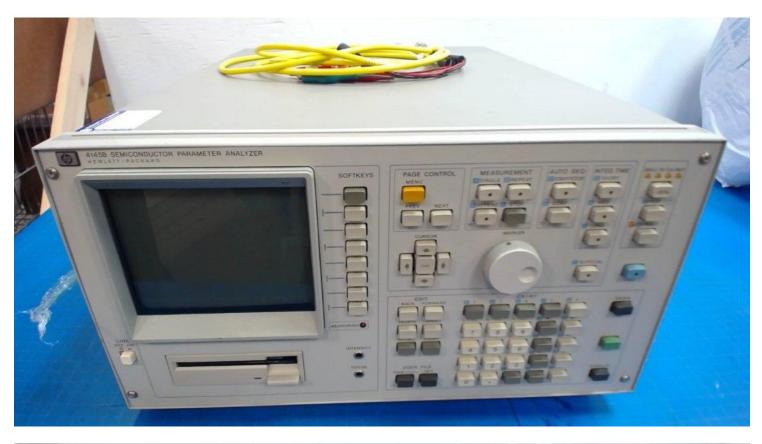
The front panel. Still in perfect condition at this point. No dings at the corners, screen bezel undamaged.

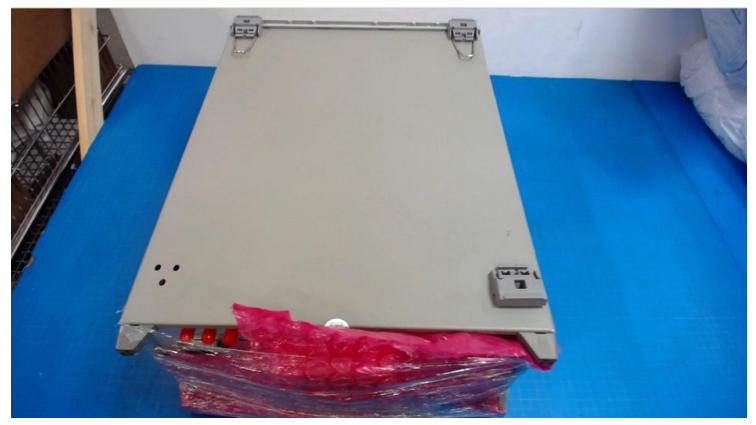
One plastic foot missing. Might have been missing as sold, don't know. But it's very easily replaced, not important.

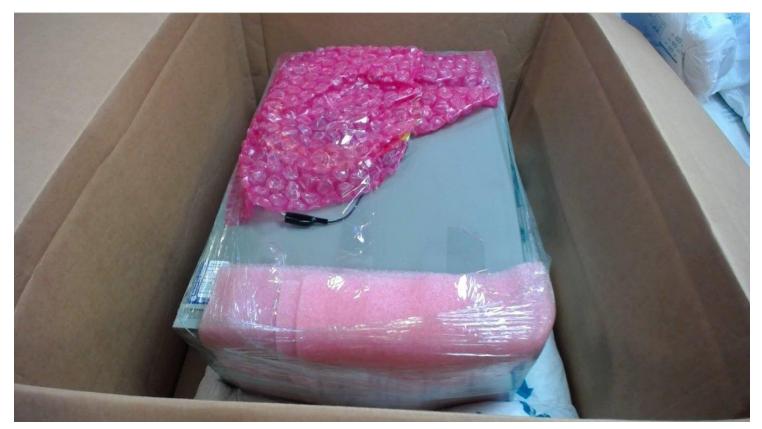
The foam packing. This is actually pretty good. The bags are a product that when activated self-inflate with urethane foam. The foam then sets into a resilient foam, formed to fit the space in which is was activated. One of the bags (front right cavity) has been removed for the photo below, so the item is visible.

The seller made a good attempt to protect both the instrument faces and corners, with several inches of impact absorbing material on all sides.

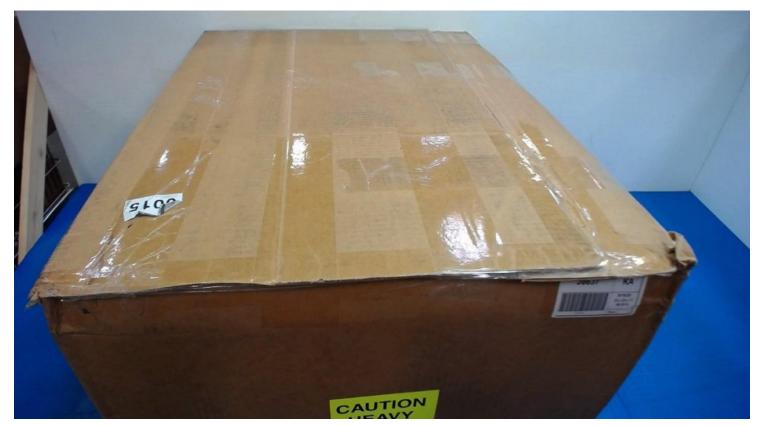
Not sure if this is the box before re-opening, or after closing it up again. I paid for the standard 'Add Fragile Stickers' service, and some were added (after this photo.) But not on every face.

Seeing the above pics, I was satisfied with the packing and proceeded to have the box shipped to Australia. Personally I'd have preferred firmer foam blocks, with more attention to corner penetration protection. But I know from experience with Shipito that they could not improve on the packing protection level this box and padding provides. Shipito only have bubblewrap, and imagine bubblewrap will work with 60lb object corners, ha ha. I gather most of their shipping business involves much lighter items than this, and they have little to no capability for repacking heavy items. So assume carrier competence, send it as is.

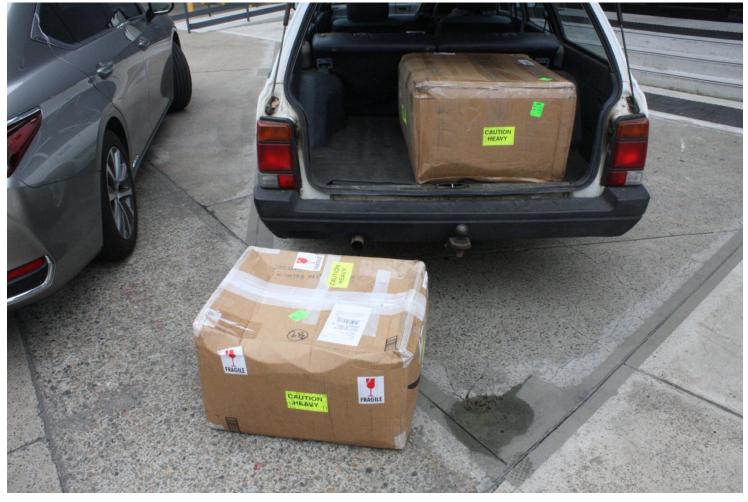
It's the large one already in my car. Both boxes were now very battered looking. I opened both right here, and took some quick pics.

I didn't fully unpack it here, just looked in from the top. It seems OK. The other box (on the ground) though even more battered, was much better packed and the content was completely unharmed. It went on the back seat, ie NOT jammed against the big one. Note that all the corner pads are in place. I didn't spot the two very small outer box penetrations.

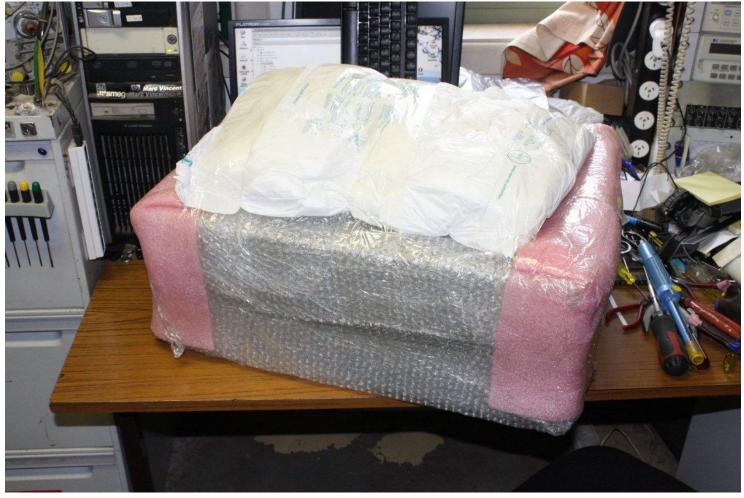
At home, out of the box. Still seems OK.

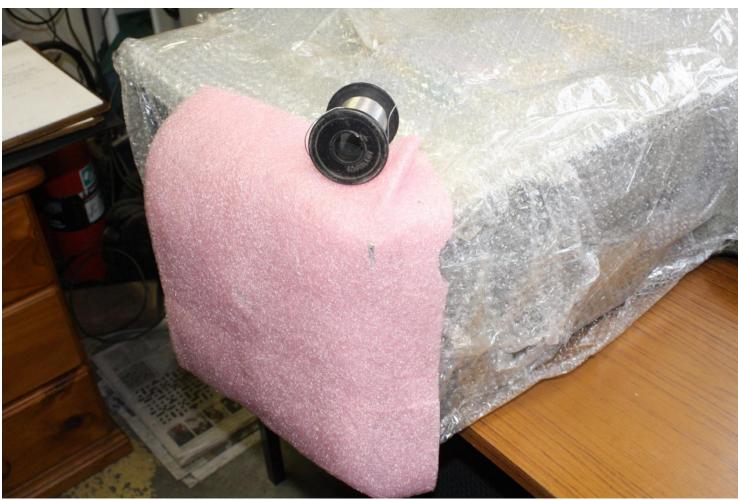
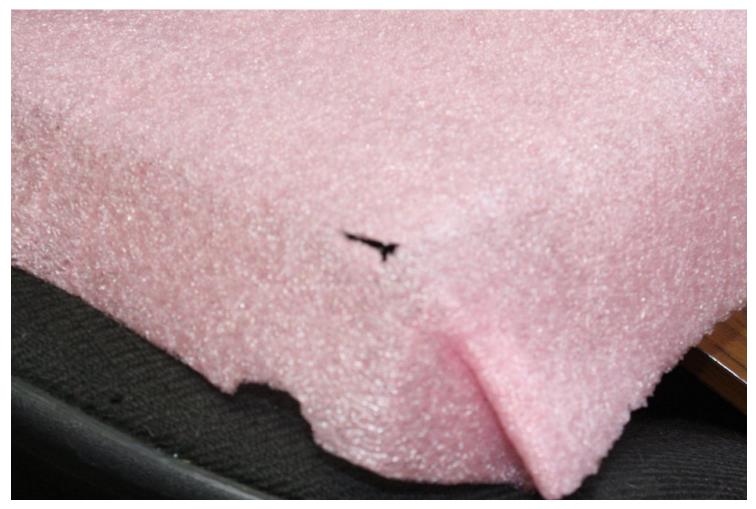
Oh oh. Only after pulling off these pink padding layers, I found the first small corner penetration. Rested the pink sheet back in place here for the photo to show orientation. (The roll of solder is acting as a weight to hold it in place for the photo.)

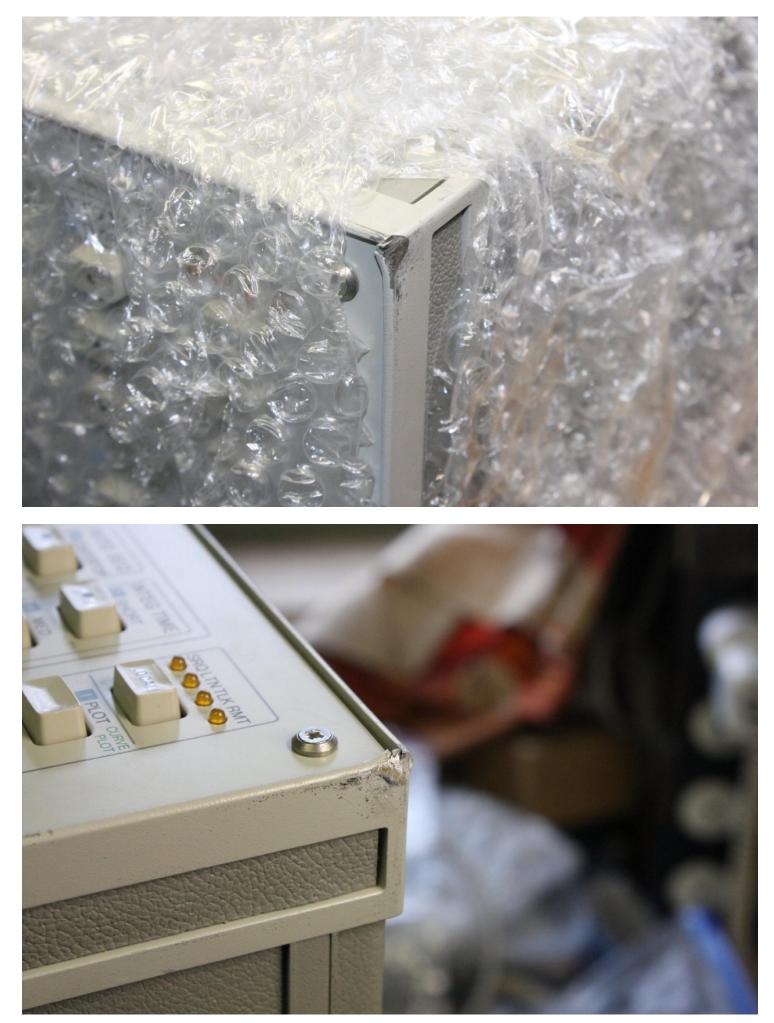
Below: This is what that tiny puncture hole in the padding means. (Useless bubblewrap torn away for visibility.)

The frame is metal. That damage to the top right front corner is the result of a very heavy impact against something unyielding like structural steel or concrete. The instrument's own weight does the rest. It has pushed the corner through all the padding AND the box cardboard, so this metal and something solid met directly.

The potentially worst, is what this high-G impact did to internals of the instrument. It has a glass CRT, very delicate. Other things can be damaged by impacts too.

This is an event that SHOULD NEVER HAPPEN with a box marked 'Fragile.' It appears to be the result of a box drop.

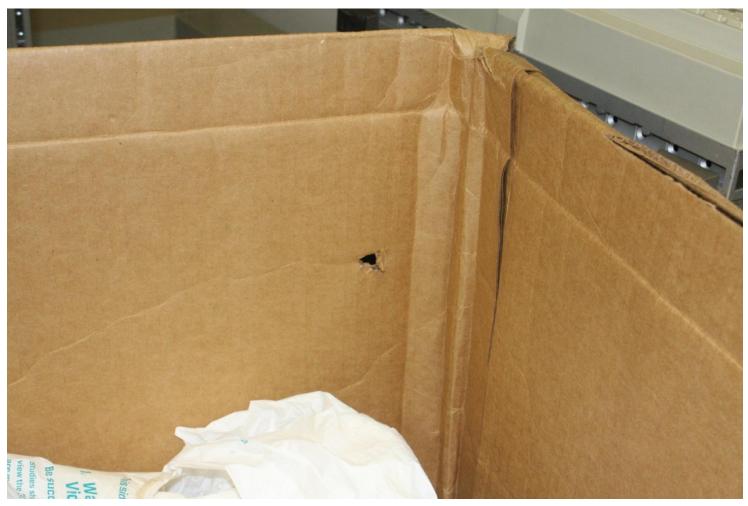
The small puncture in the box cardboard corresponding to that corner's damage.

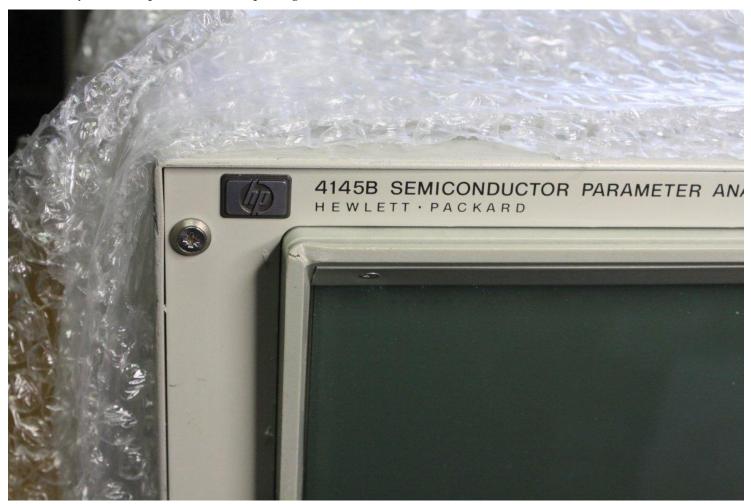
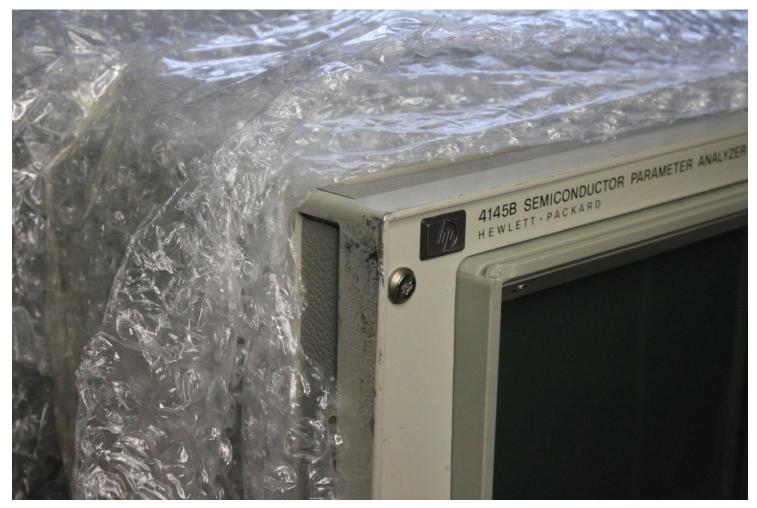
Two more small damages. A ding in the plastic screen bezel, and an impact deformation to the upper left metal frame. I can't see any visible box penetrations corresponding to these.

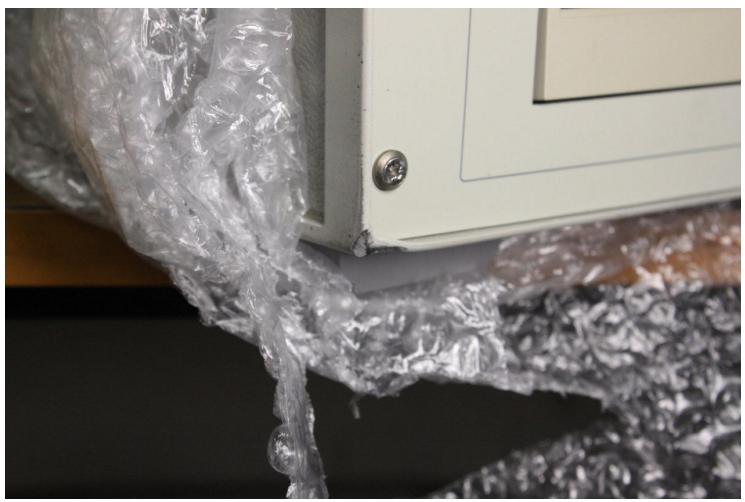
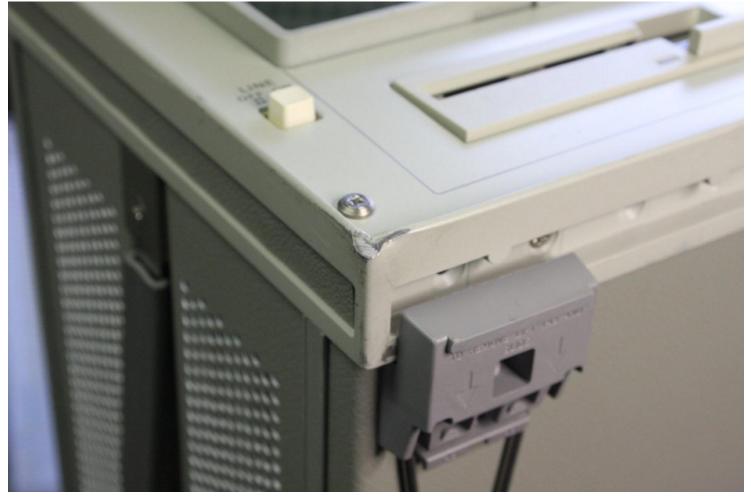
ANOTHER bad impact damage to the front frame. This one to the lower left corner.

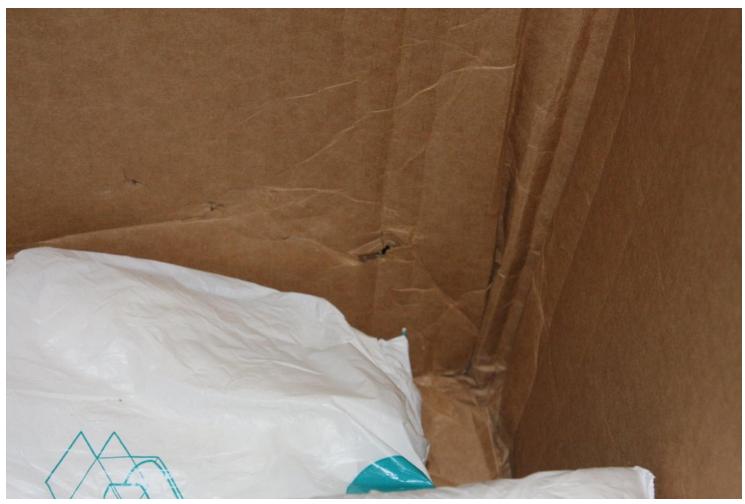
Box cardboard penetration from the lower left ding.

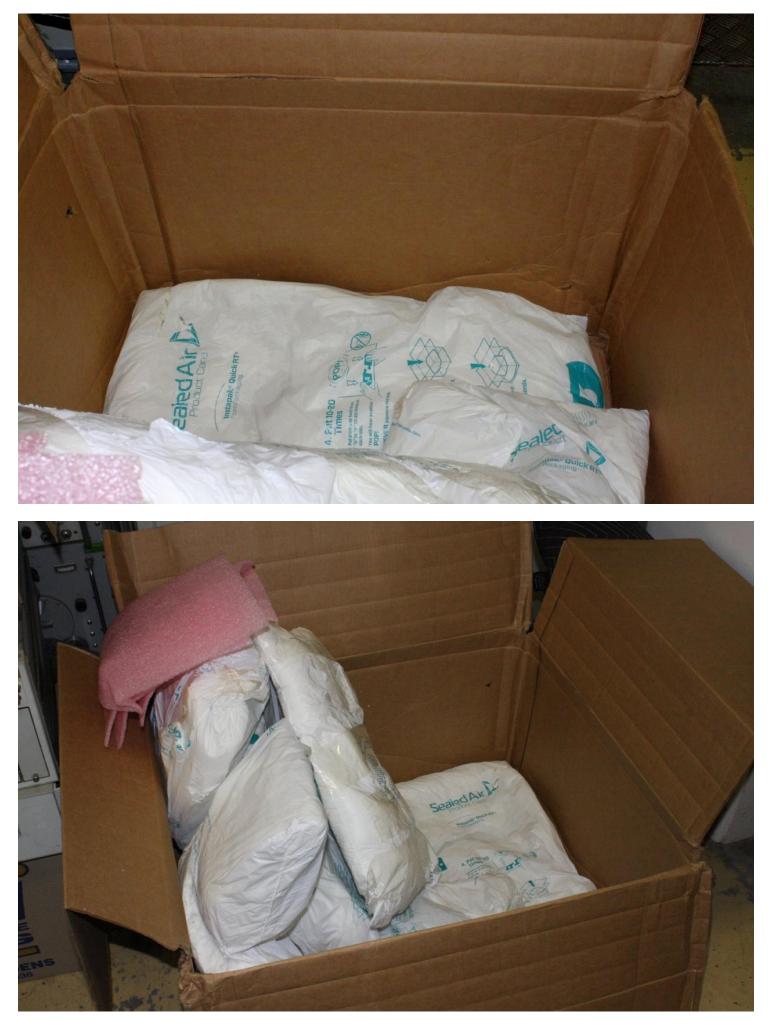
More box interior views.

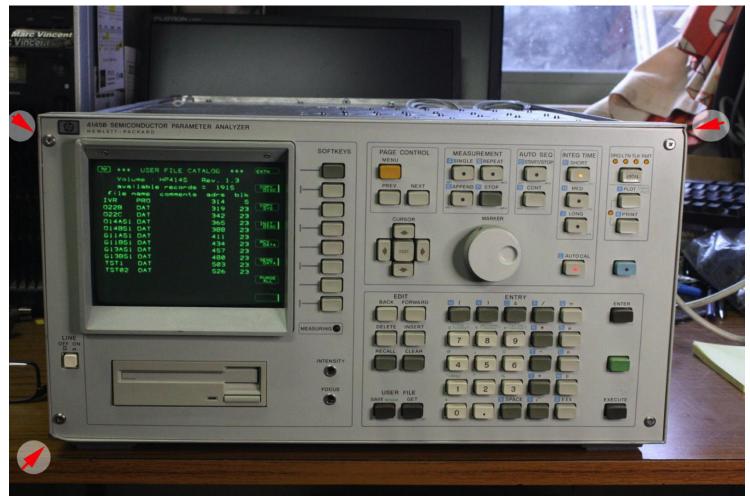
View of the front face showing how obvious the bent corners are. (The top cover I removed for a visual check of internals before powering up.) It still works, but has lost that visual 'perfect condition' attribute.
