CAUTION LETHAL VOLTAGES ARE PRESENT ON THE BARE PCB
 This schematic was traced from the PCB. There may be errors and omissions.
 Some component designators and values are missing, as they were not visible on the PCB.
 This schematic is a graphic only. Some components are not true symbolic parts.
 Eg: T1, T2, Jc1, ETC.

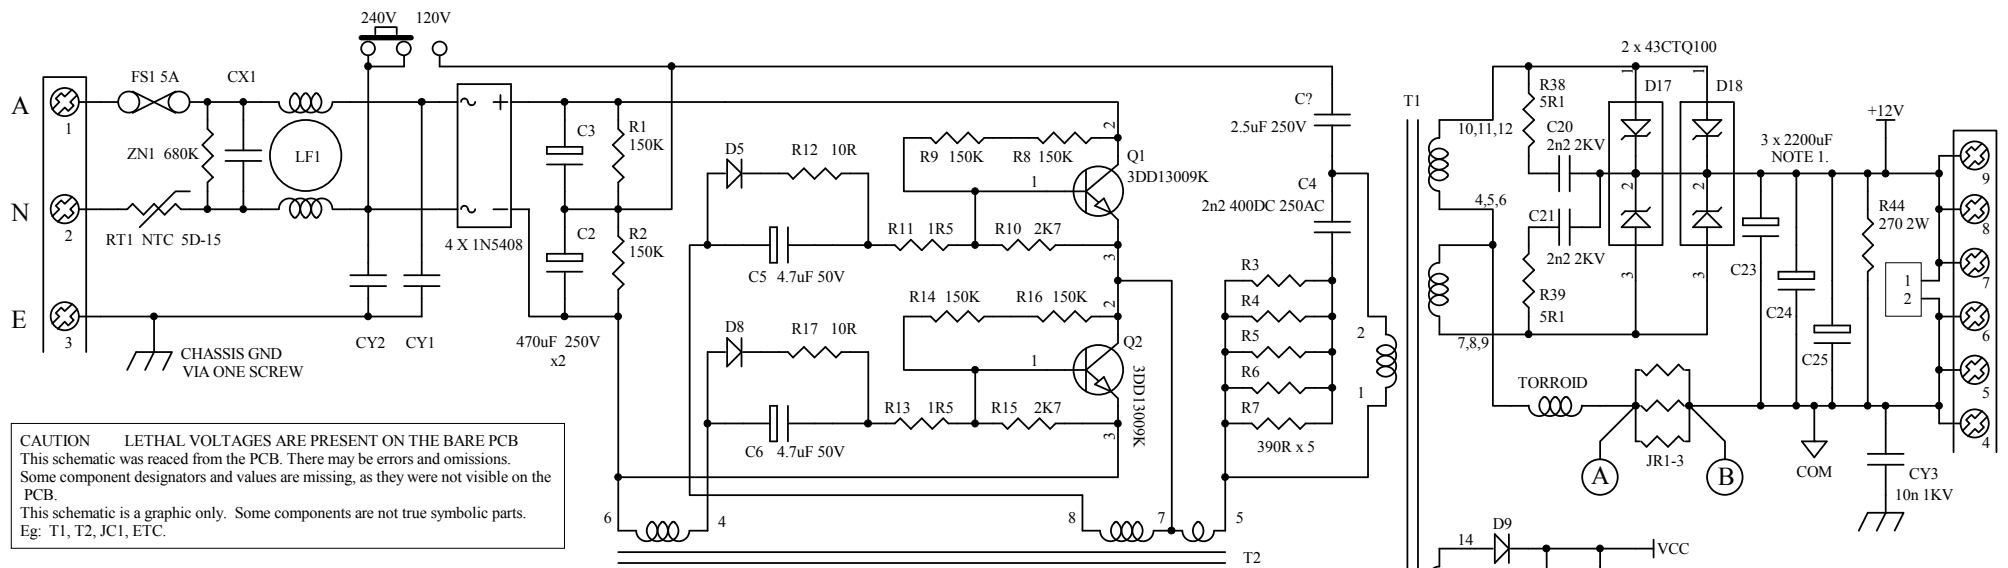
NOTE 1: C23, 24, 25 WERE RATED 10V ON THE SAMPLE RECEIVED. THESE MUST BE RATED 16V OR HIGHER. REPLACE IF INCORRECT.
